SEATTLE PARKS DEPARTMENT  
MAGNUSON PARK/SAND POINT  
BUILDING 2  
JURISDICTIONALLY REQUIRED  
UPGRADE ANALYSIS

February 29, 2008

## **Sandpoint Building 2**

### **Brief Structural Condition Survey and Upgrade Recommendations**

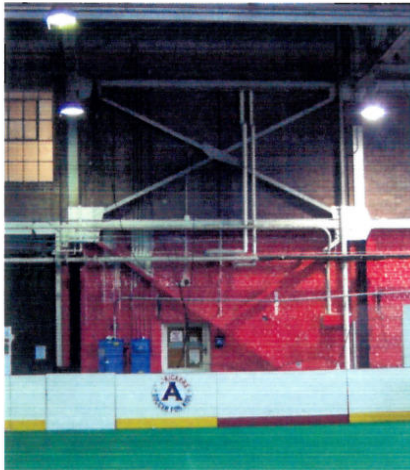
## 2. E-W Vertical Bracing at Side Walls of Hangar Space

Vertical bracing at hangar side walls is inadequate. In some cases, it has been deleteriously modified for functional reasons. (See photo.) New bracing members between columns need to be added in several column bays on each side of each hangar. New bracing have strength and detailing to comply with modern seismic regulations.

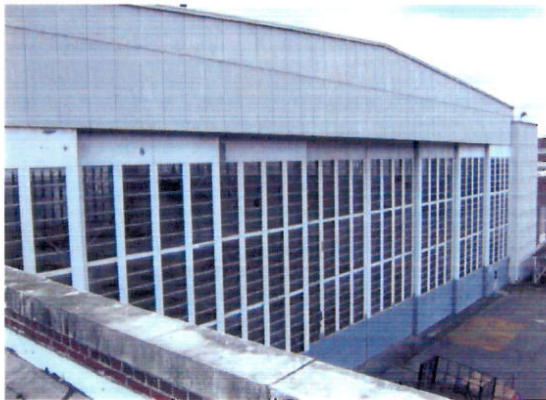
## 3. N-S Vertical Bracing at Hangar Doors

Additional vertical bracing will be needed in the north-south direction. New bracing may be required adjacent to the hangar doors, partially obstructing the doors. This bracing could be compatible with the historic features of the building. (See adjacent photo.) The hangar doors are most likely not needed for any anticipated future building functions.

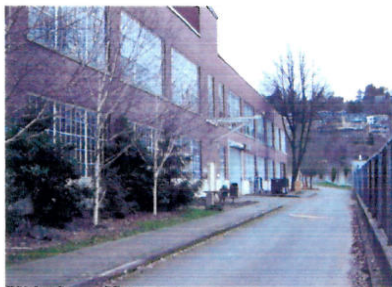
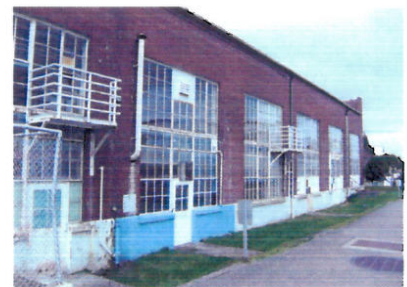
## 5. E-W Shear walls at North and South Side

New shear walls or braced frames will also be needed at the north and south sides. Infilling windows with concrete walls or braced frames is the likely solution.

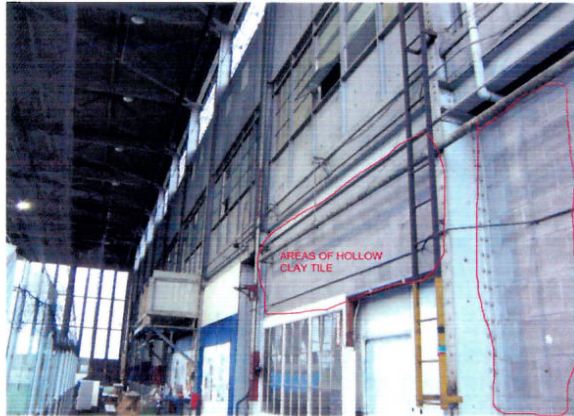
## 7. Unreinforced Brick or Hollow Clay Tile Walls.

These walls, subject to collapse in a significant seismic event, are located throughout the facility. Common remediation solutions include strengthening with steel framing or fiberglass reinforcement, or removal.
